# UPPER LEHIGH RECLAMATION PROJECT

**NOMINATION  
OF THE  
UPPER LEHIGH  
BACKFILLING STRIP PITS  
OSM 40(3222)101.1  
ABANDONED MINE RECLAMATION PROJECT**

**1997 NATIONAL ABANDONED MINE LAND  
RECLAMATION AWARD  
NOMINATION**

Backfilling Strip Pits  
Upper Lehigh  
Foster Township  
Luzerne County, Pennsylvania  
Contract No. OSM 40(3222)101.1

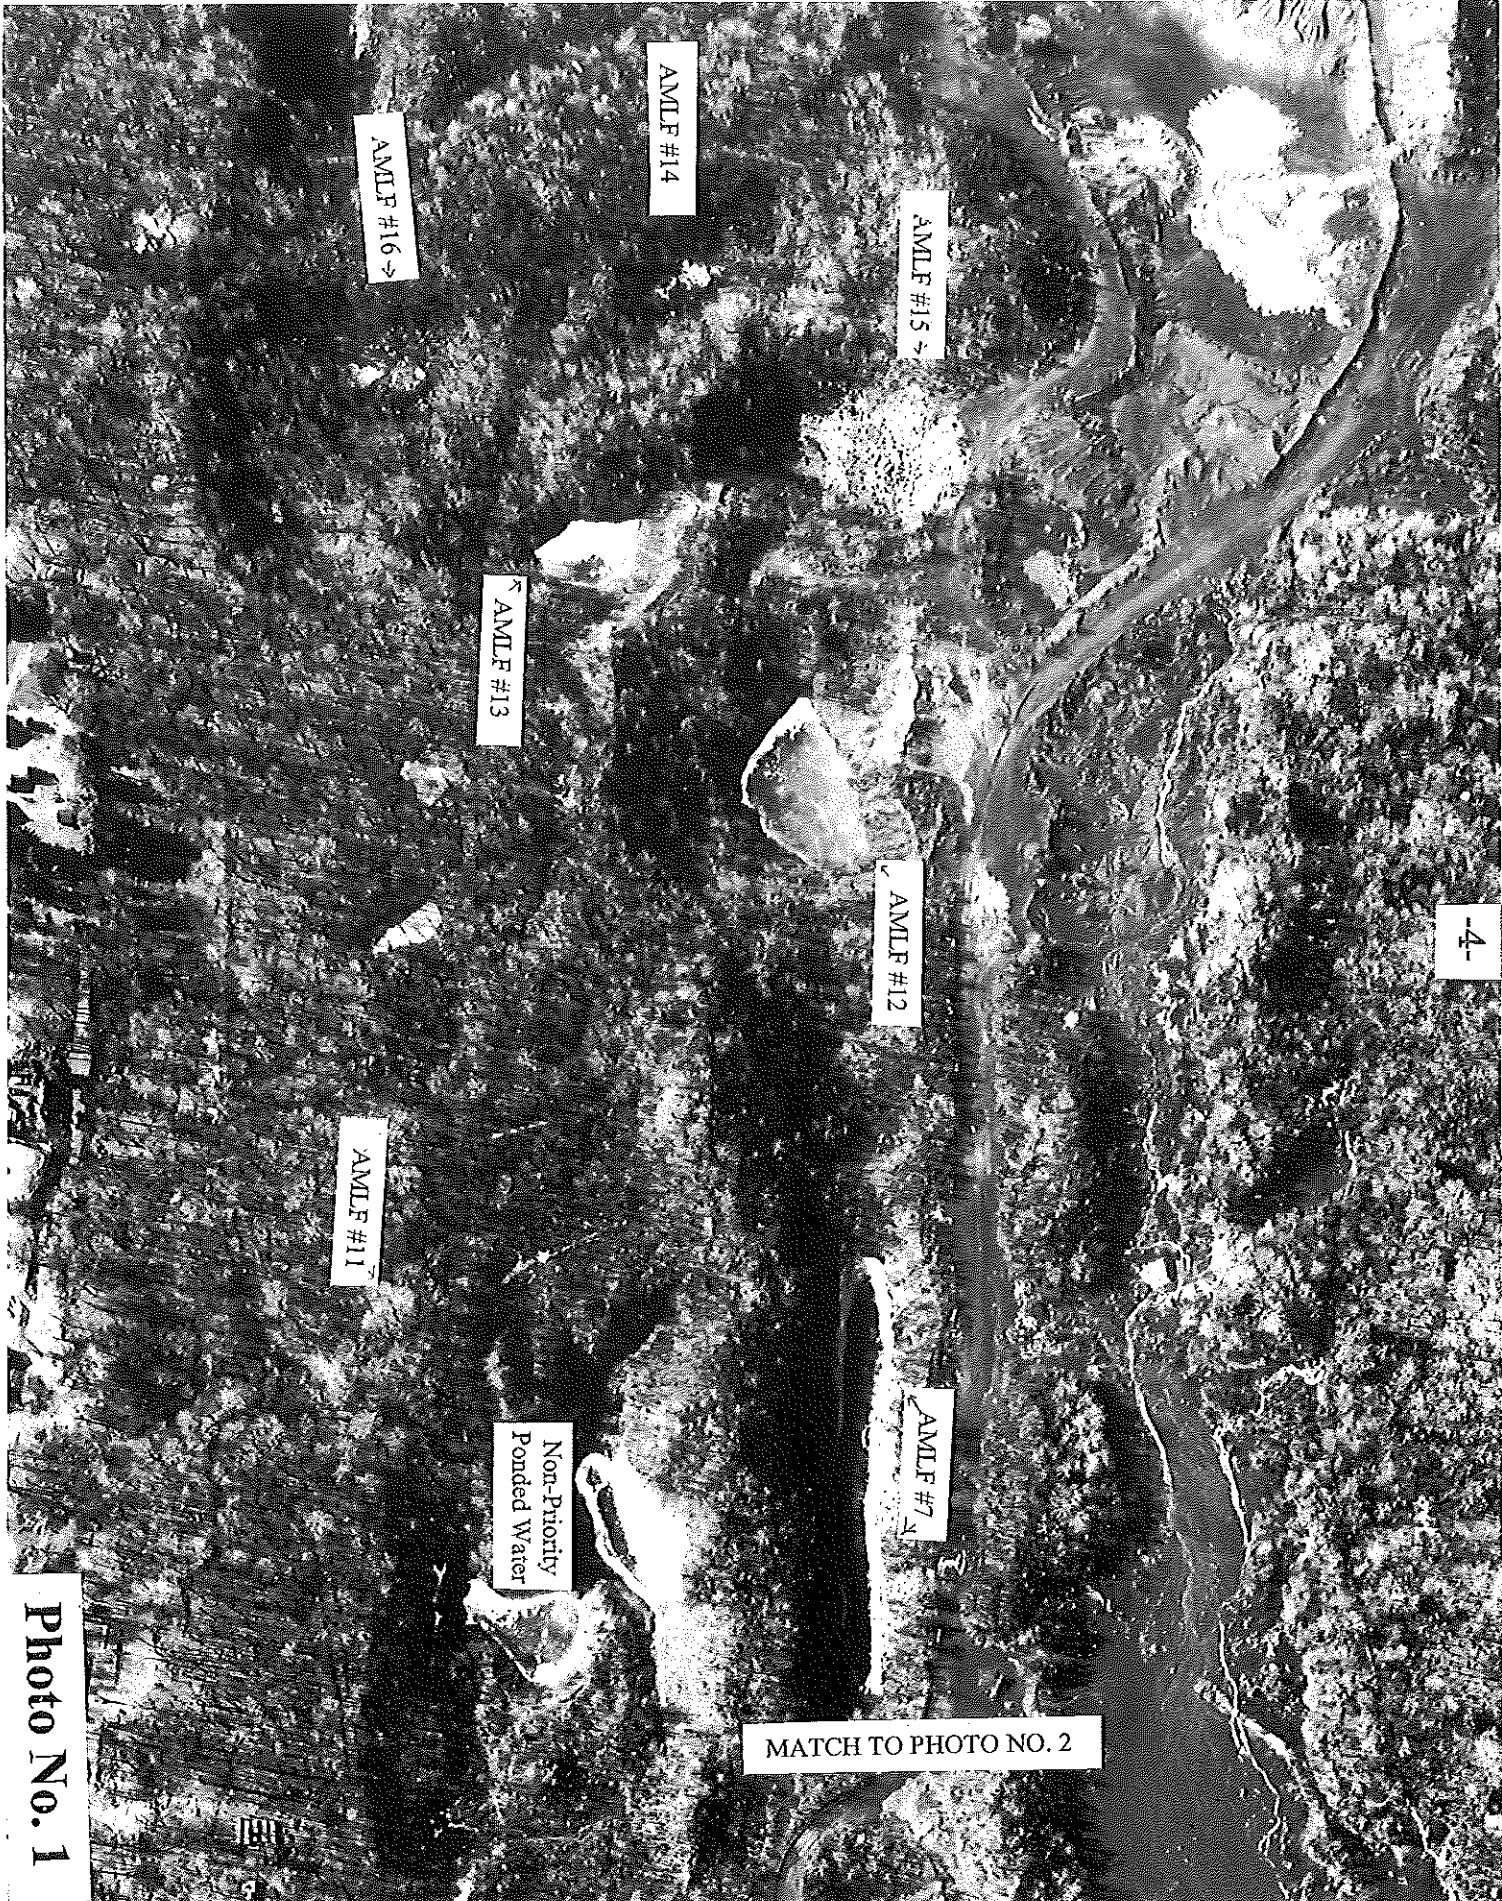
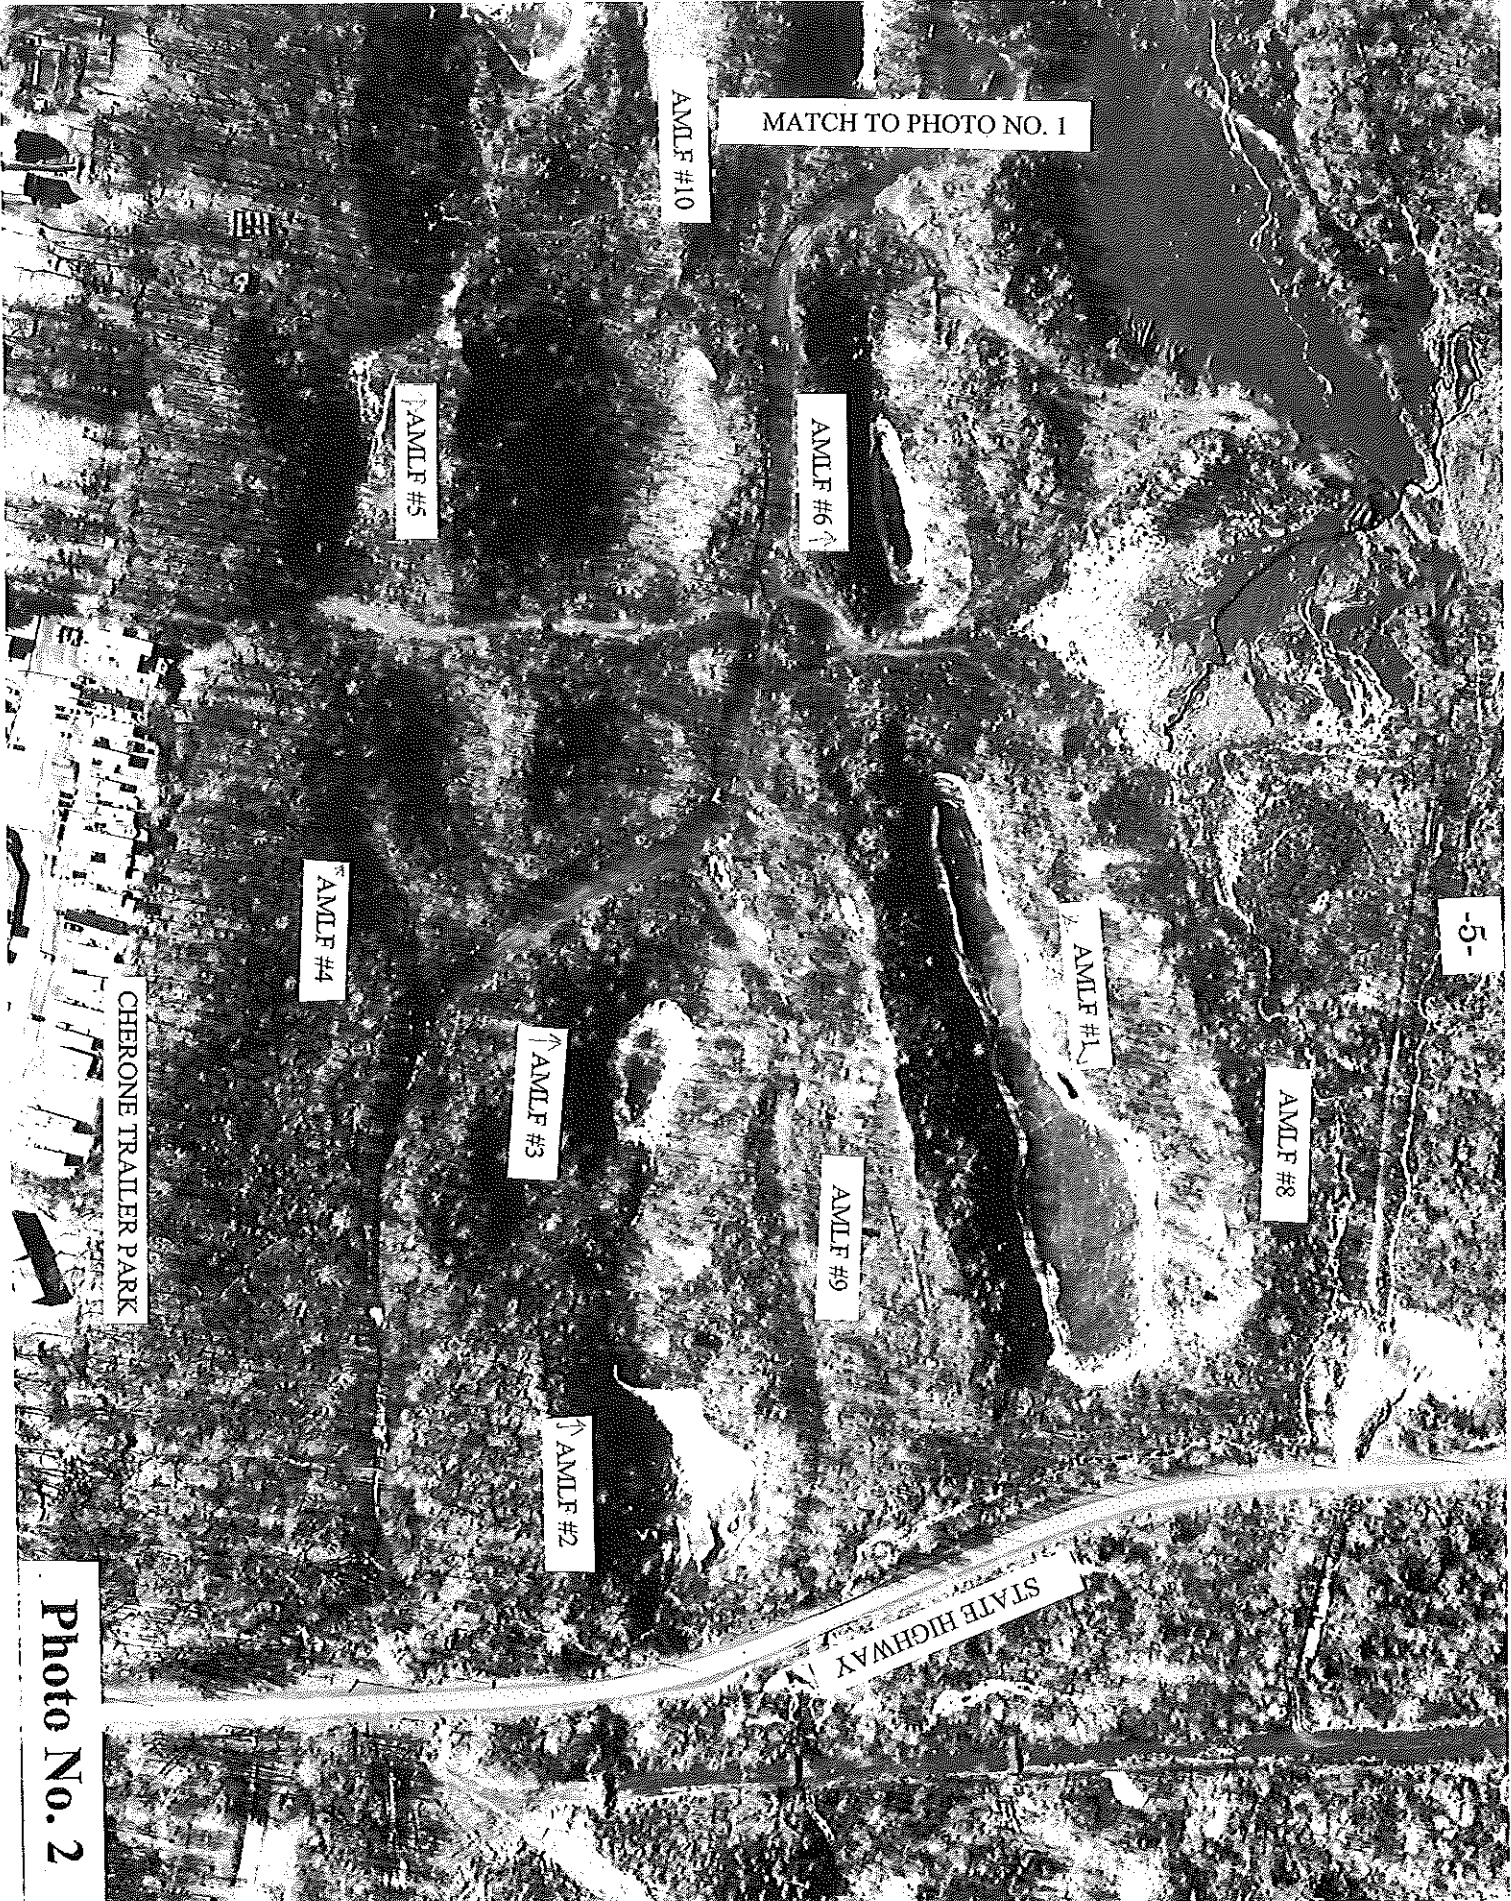
Photo No. 1

These photographs depict preconstruction conditions at the site. The features and landmarks are identified on the photos. The physical descriptions of the numbered features as they existed prior to construction are as follows:

AMLF 1 (DH,HWB): This pit is located 75' west of heavily traveled State Route 2049 (Birkbeck Street) and 800' north of the Cherone Trailer Park off Schwabe Street in Freeland. This flooded strip pit is approximately 700' long x 150' wide x 30' deep. A dangerous highwall exists along the western end measuring 150' long x 30' high with a 40 degree slope to the water's edge. The perimeter of the pit consists of unconsolidated spoil material at slopes of up to 35 degrees. Access is via footpaths from S.R. 2049.

AMLF 2 (DH, HWB): This feature is located 250' south of AMLF 1, 600' north of the Cherone Trailer Park in Freeland, and 50' west of S.R. 2049. It is a partially flooded pit approximately 300' long x 250' wide x 30' deep. The water body measures 200' x 125' x unknown depth. There is nearly vertical highwall along the south side measuring 100' long and 30' high. Large amounts of discarded tires are located on the south side. Access is via a haul road along the northern side to the edge of the pit and a foot path leads to the pit from S.R. 2049.

AMLF 3 (DH, HWB): This feature is to the west and is a continuation of the pit which is AMLF 2. It is a partially flooded pit approximately 200' long x 100' wide x 50' deep. The water body measures 170' x 80' x unknown depth. There is dangerous highwall along the western and northern sides measuring 300' long and 50' high having a slope greater than 35 degrees consisting of unconsolidated spoil material. Large amounts of discarded tires are along the east and south sides and in the pit's center. Access is via haul roads located along the north, west, and south sides. The haul road is within 15' of the edge of the pit at the western and northern ends.

AMLF 4 (DH): This feature consists of 2 small adjacent pits. The pits measure about 150' in diameter and 50' deep and 200' x 100' x 30' deep containing about 500' of highwall. They are located 150' southwest of AMLF #3 and 300-400' north of the trailer park. Dangerous highwall having slopes of up to 50 degrees exists along the perimeter of both pits. Access is via a haul road located along 3 sides of the northernmost pit and along the east and west sides of the southernmost pit

AMLF 5 (DH): This feature is located 350' northwest of the trailer park in Freeland and 80' west of AMLF 4 with a haul road between the two features. The pit measures 400' long, 250' wide, and 50' deep. Dangerous highwall exists on the south (200' x 50') side of the pit. Access is via a haul road located on the east and north sides of the pits. The haul roads are within 30' of the pit's edges.

AMLF 6 (DH, HWB): This water-filled pit is located 1200' southwest of AMLF 1 and along the same vein. The pit measures 430' long, 150' wide, and 40' deep to the water surface. The water body measures 170' x 30' x unknown depth. Dangerous highwalls having a slope of 35 degrees exist along the northern, eastern, and southern sides measuring 450' long and 30-40' deep. Garbage dumping is occurring in the eastern and western ends of the pit. The area is easily accessed by a haul road 15' to the south, east, and west sides. The haul road to the west divides this pit from AMLF 7.

AMLF 7 (DH, HWB): This feature is located 100' west of AMLF 6 and 800' north of residences in Freeland. It is approximately 600' long, 150' wide, and 40' deep to the water surface, which measures 470' x 40' x 25' deep. The south highwall measures 470' and consists of fractured bedrock at a near vertical angle dropping to the water surface. The north highwall is about 470' long and consists of loose, unconsolidated material at a 35-50 degree slope to the water surface. Visitation is evident by the extensive amounts of residential garbage along the northern and eastern sides of the pit and within the water body. Access is via a haul road within 15-25' along the entire north side. Spoil piles are along the south side.

AMLF 8 : This non-priority feature is a spoil pile which lies along the entire northern side of AMLF 1. The spoil pile covers an area of about 700' x 150' with individual piles ranging to 25' high.

AMLF 9 : This non-priority feature is a spoil area situated between AMLF 1 and the pit which contains AMLF 2 and AMLF 3. Spoil along the entire south side of AMLF 1 ranges to 25' in height.

AMLF 10 : This non-priority feature is a highly disturbed spoil area along the western sides of AMLF 5 and AMLF 6, and encircling AMLF 7. Individual spoil piles range from 15' to 35' high.

AMLF 11 (P): This feature is located along the north side of residences in Freeland and 400' of a residence located at 1141 Schwabe Street. This portal is located at the bottom of a concrete slope which measures 40' long x 7' high and extends at a 20 degree slope. The slope ends in a partial blockage of the portal at which point a 2' x 3' opening extends into the slope, which is 5' x 10' x unknown length. The slope continues in a northerly direction for an unknown distance. Well worn footpaths and garbage at the opening were present on the day of investigation. The area is 80% revegetated. The area around the opening is subsiding into the opening and is large enough for someone to fall into and become trapped. The portal and subsided area surrounding it is periodically flooded, as observed during several site visitations.

AMLF 12 (DH, HWB): This feature is located 300' west of AMLF 7 and measures 300' in diameter and 35' deep to the water's edge. There is dangerous highwall along the north side of the pit consisting of loose spoil material with a 35-50 degree slope and measuring 200' long and 35' high. The water body measures about 130' in diameter with an unknown depth. Access to the pit is by a haul road 40' to the north of the pit.

AMLF 13 (HWB): This feature is located 50' southwest of AMLF 12 and measures 150' in diameter and 25' deep to the water's edge. The pit is surrounded by spoil material. This feature is separated from AMLF 12 by a 30' spoil pile. The water body measures about 80' in diameter with an unknown depth. A footpath runs along the southern edge of the pit.

AMLF 14 (DH): This feature is located 120' west of AMLF 13 with a 30' spoil pile between the two features. The L-shaped pit measures 200' x 100' x 40' deep. Several footpaths traverse the area surrounding the pit. The sides of the pit consist of unconsolidated spoil at slopes greater than 35 degrees. The dangerous highwall measures 100' long x 40' high. There is a large rock outcrop near the bottom of the pit. A 40' spoil pile lies about 20' north of the pit.

AMLF 15 (IRW): This feature is located 50' west of AMLF 12 and 20' northeast of AMLF 14. A haul road runs along the northern rim of the pit. A large amount of garbage has been dumped along the north slope and into the bottom of the pit. The pit measures 225' in diameter with side slopes consisting of loose spoil material.

AMLF 16 (DH): This feature is located 140' southwest of AMLF 13. The oval-shaped pit measures 150' wide and 250' long. There is dangerous vertical highwall consisting of fractured rock 75' long x 25-30' high in a U-shape around the northern and western sides of the pit. A small stream runs into the pit at the southern end. There are footpaths along the northern and western sides of the pit.

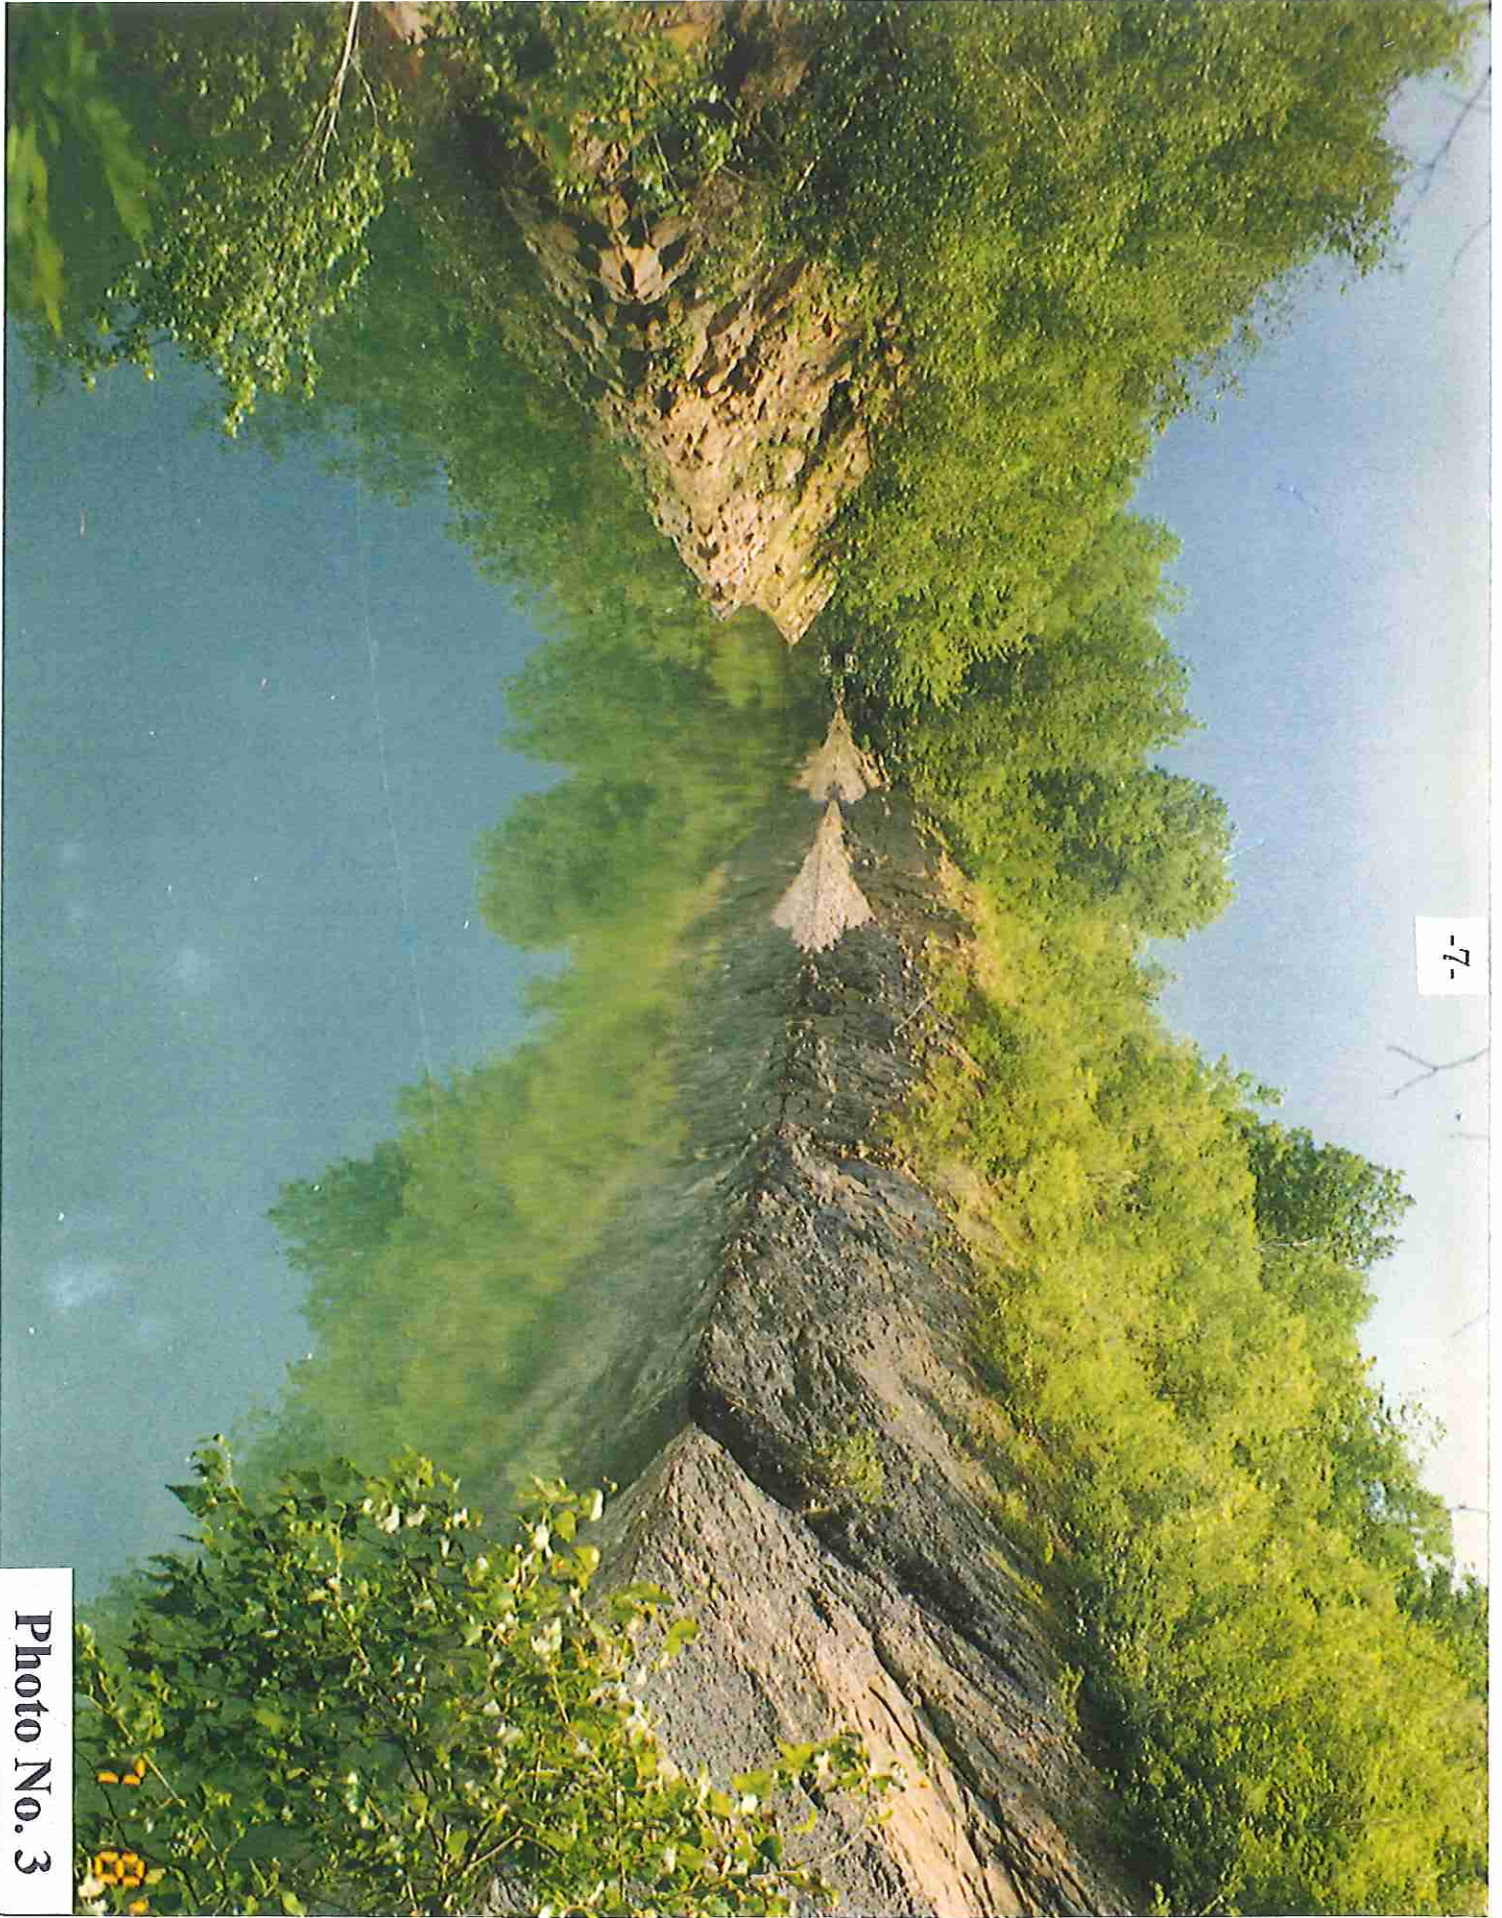
Photo No. 3

This is AMLF 7, where 8-year old Derrick Hittinger drowned on September 5, 1992. The accident occurred at the same time of year as this picture was taken. During that fateful summer afternoon Derrick and his cousin rode their bikes to a point where they could look over the highwall to see if there were any fish in the water filled pit. Derrick lost his footing and slid down the steep rock highwall into the water, where he struggled to climb out and drowned before help could reach him. The ironic ending to the story is that the water quality in the pit was so poor that it is doubtful any fish could have survived in it.

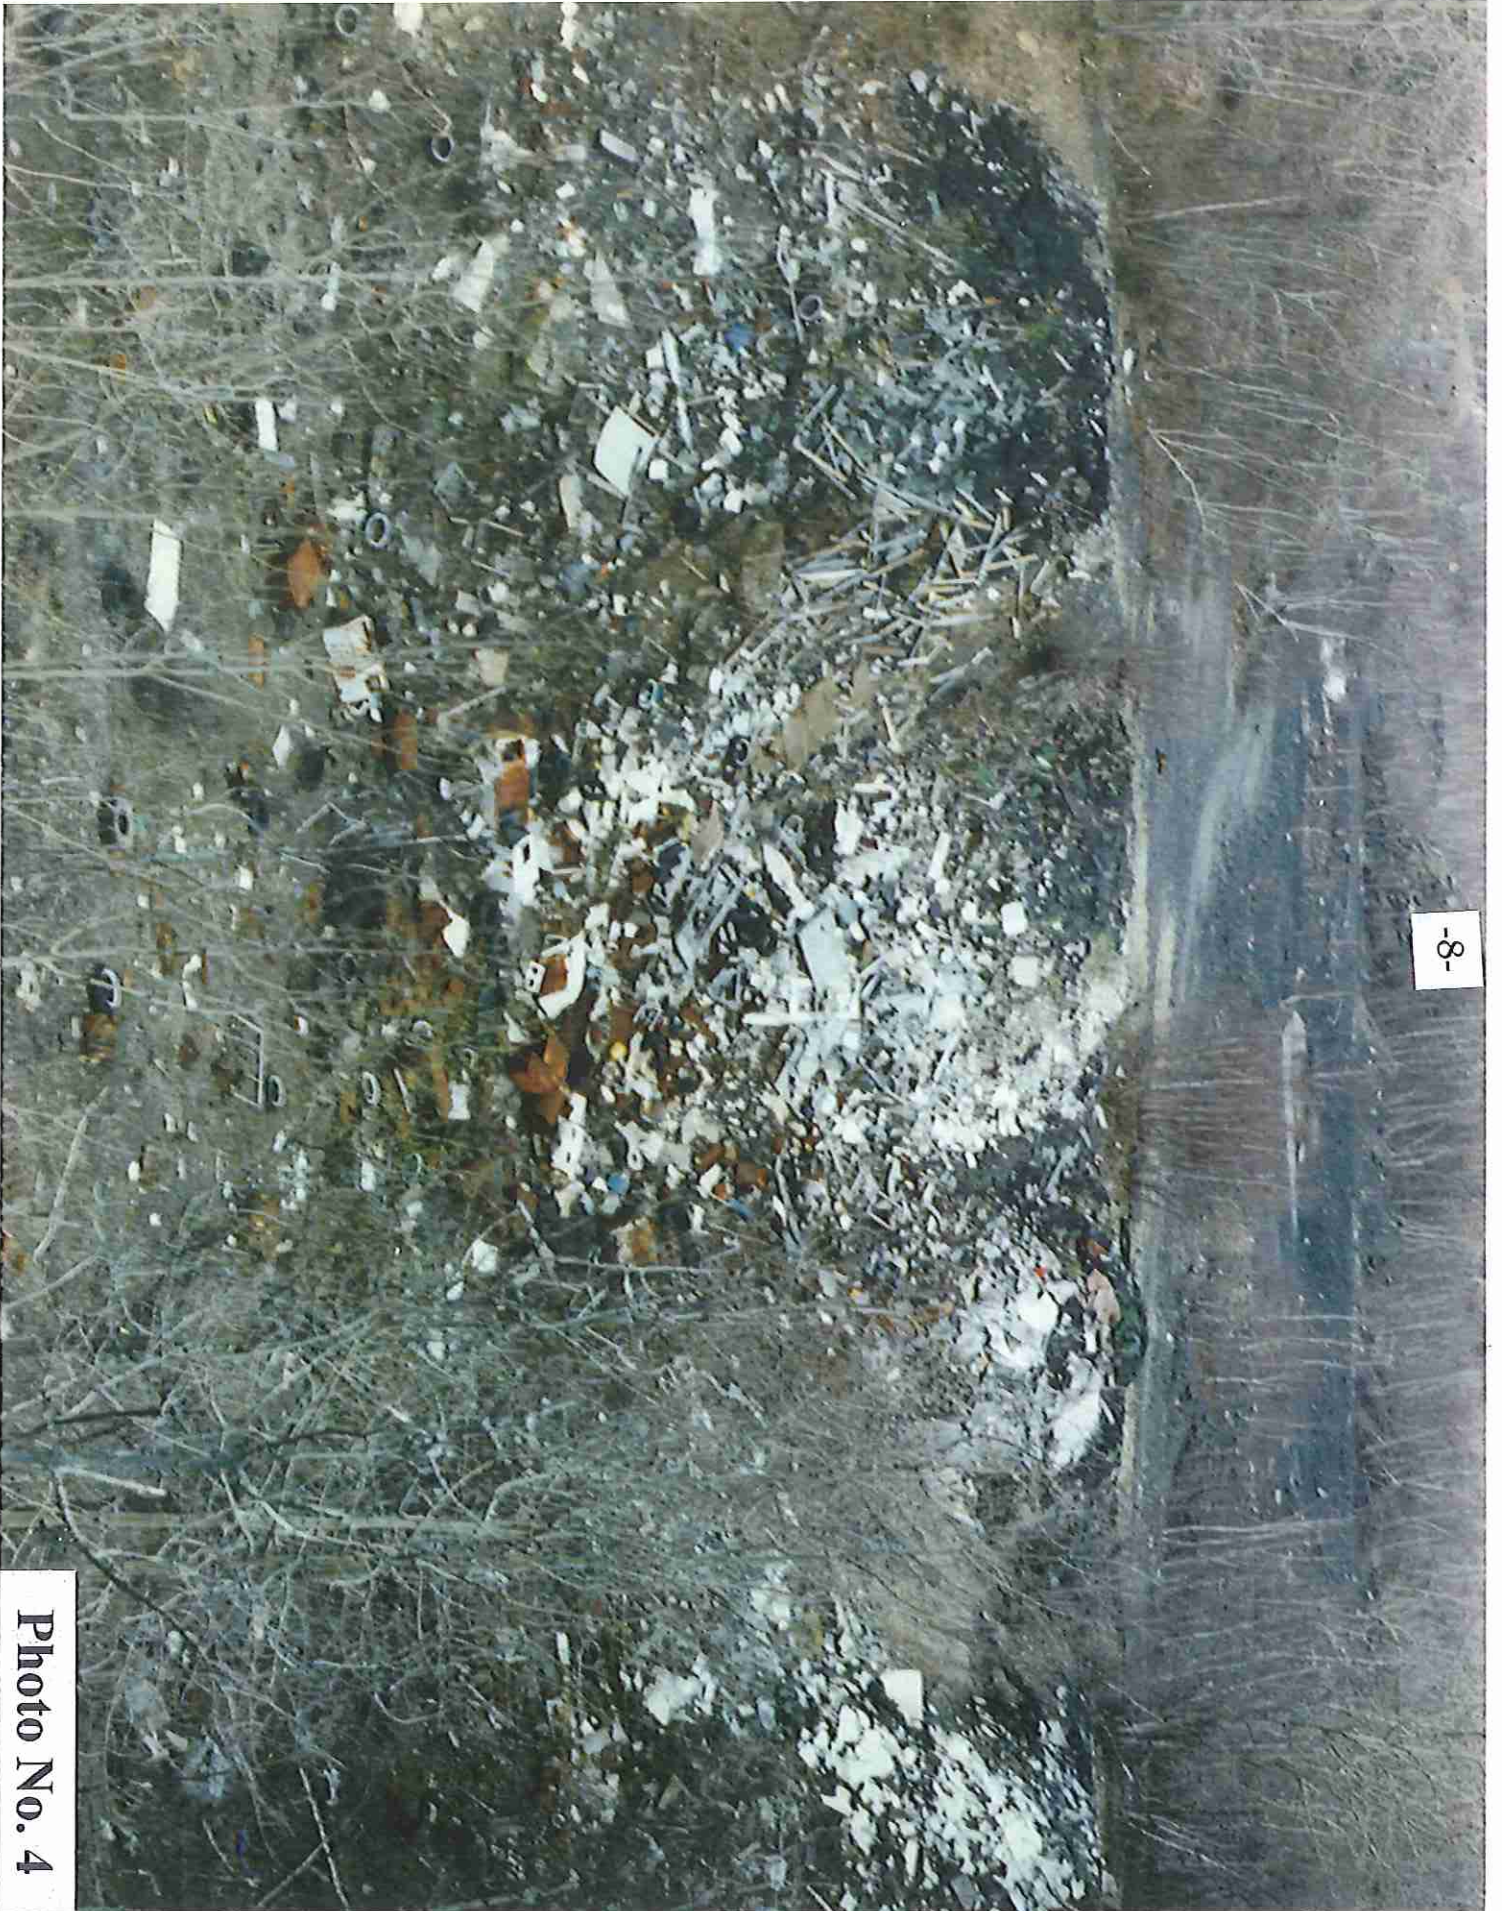
Photo No. 4

These photos were taken during construction just prior to earthmoving activity. They depict typical conditions that existed in this problem area such as: dangerous highwalls, hazardous water bodies, and garbage dumping.

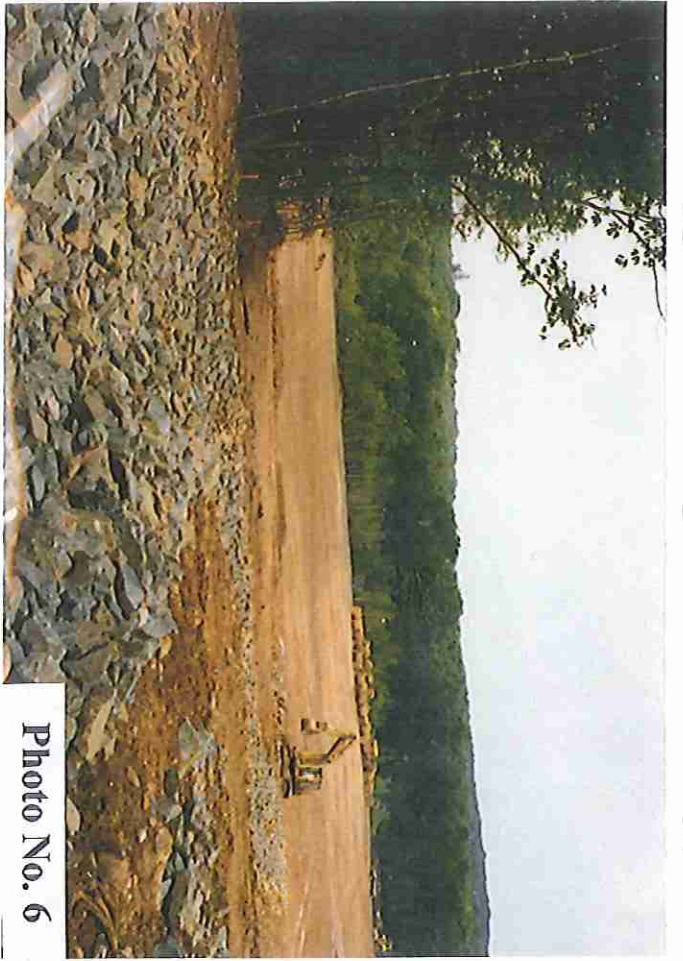
Photo No. 6

The picture shows the construction of a rock lined channel that is now conveying the flow from a small stream into Wetland A.

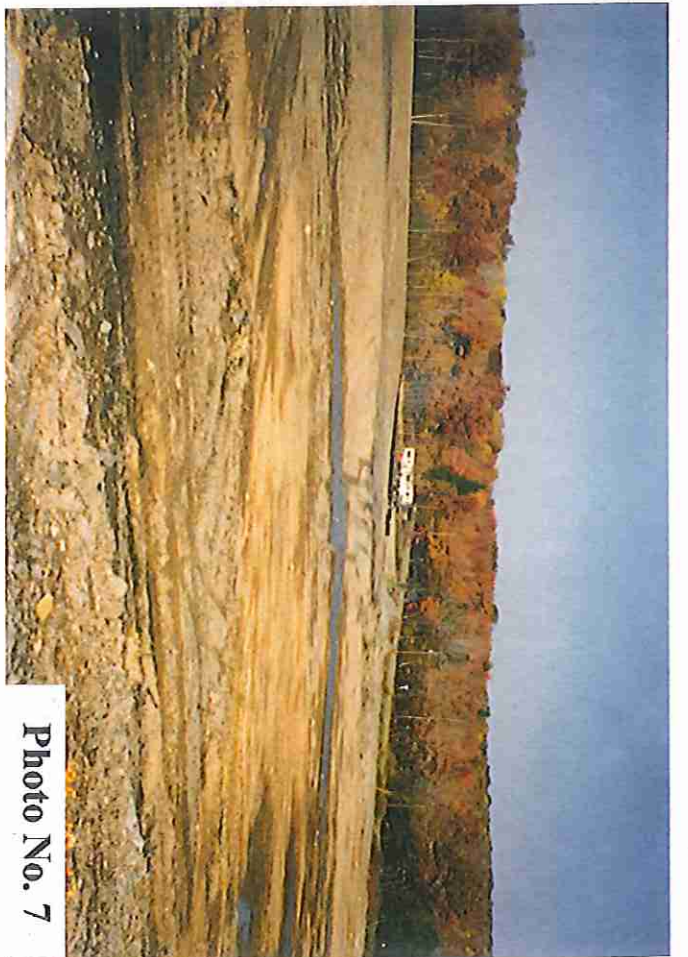
Photo No. 7

This photograph is of freshly graded Wetland B just before it is seeded and before its source of hydrology is introduced. The field office trailer can be seen in the background.

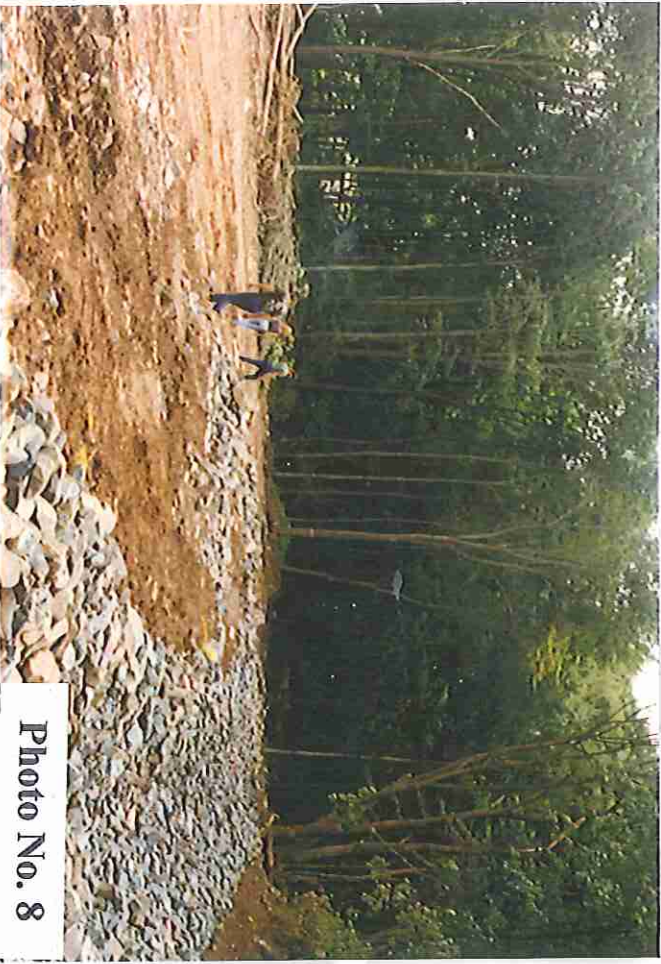
Photo No. 8

This a picture a newly constucted riprap channel that will carry storm water flows into the constructed wetlands.

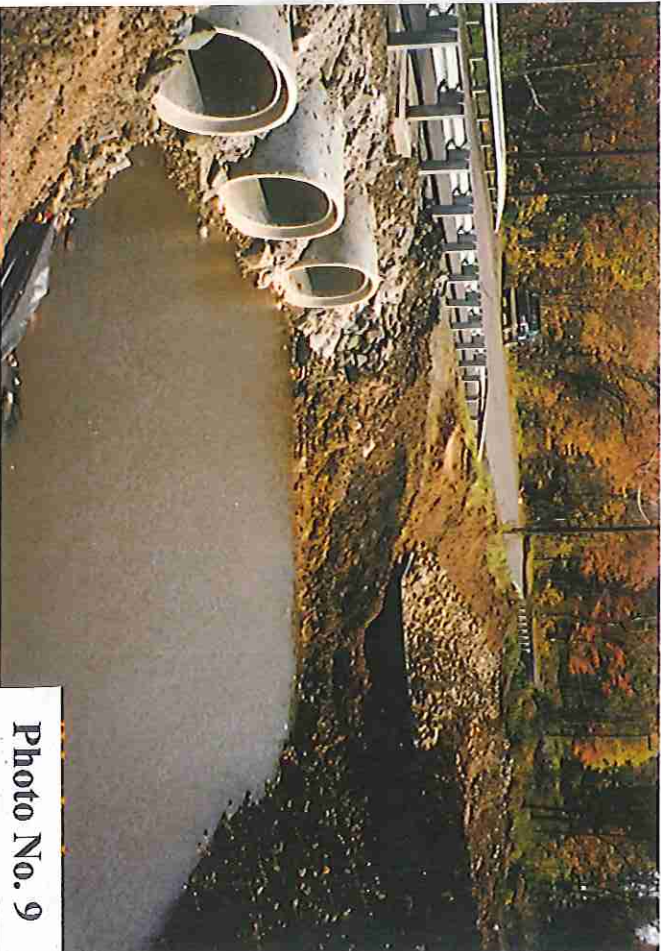
Photo No. 9

The photograph depicts the culvert constructed under this contract that PennDOT agreed to pay for. This structure was designed to convey the portion of the 25 year storm that is not detained by the storm water storage capacity of wetlands. On the top of the picture one can see a rock lined channel that now carries storm water from the Borough of Freeland.

The Bureau contacted PennDOT during the early stages of design to raise concern over a clogged and deteriorating 48 inch corrugated metal pipe that was vastly undersized to convey almost any storm event that occurred in the watershed above it.

After much dialog and meetings between designers, it was agreed the reclamation project would be designed in such a manner that surface water would be retained on the site at a rate that would allow for a 25 year storm to pass through three (3) 38 in. X 60 in. elliptical pipes installed under the highway.

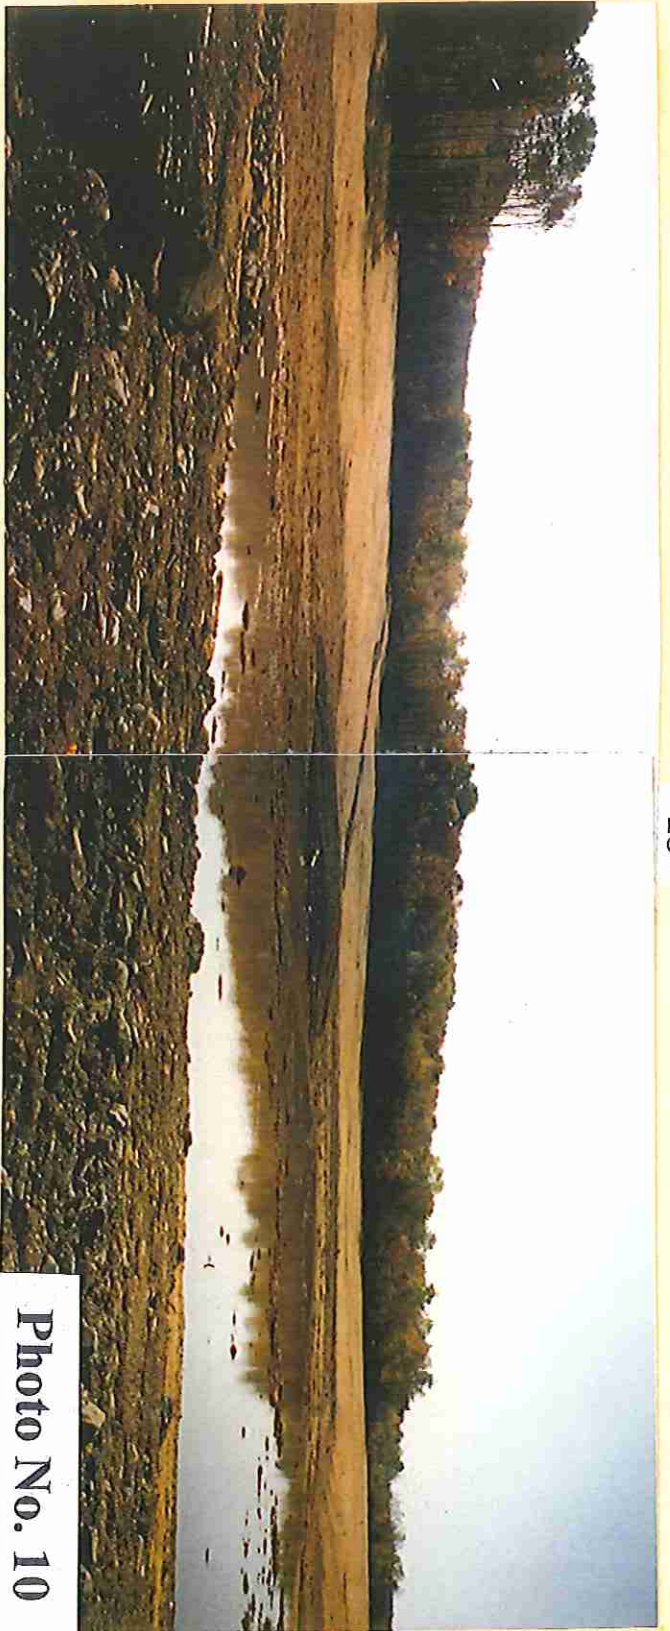
Photo No. 10

This photograph is of Wetland A as a flow is introduced into it. In the background one can notice that a constructed channel is conveying water into the wetland.

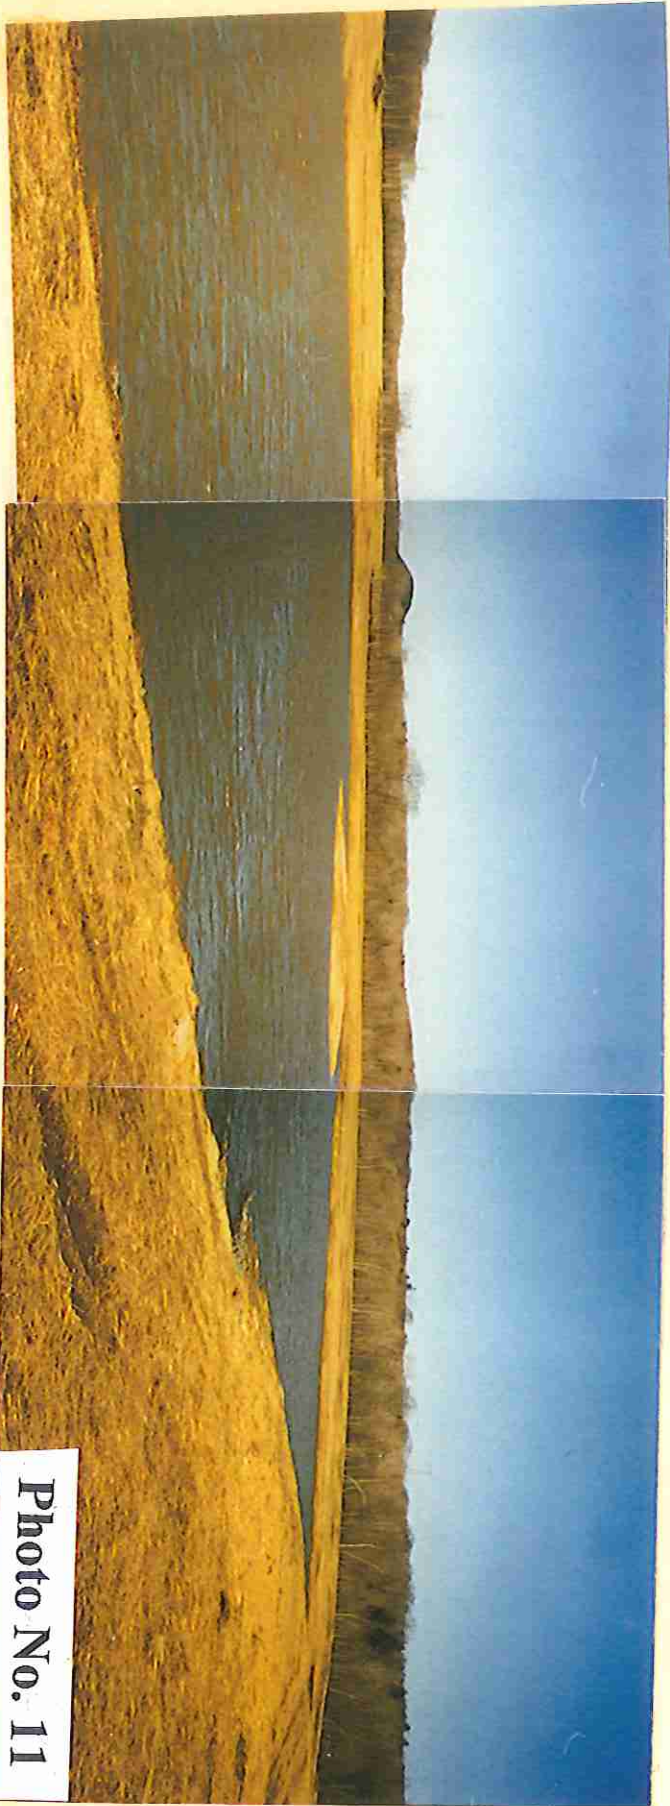
Photo No. 11

This picture was taken from the State Highway on the day of final inspection. The photo is of Wetland C and displays the portion of the reclamation motorists will see as they drive by the Upper Lehigh site.

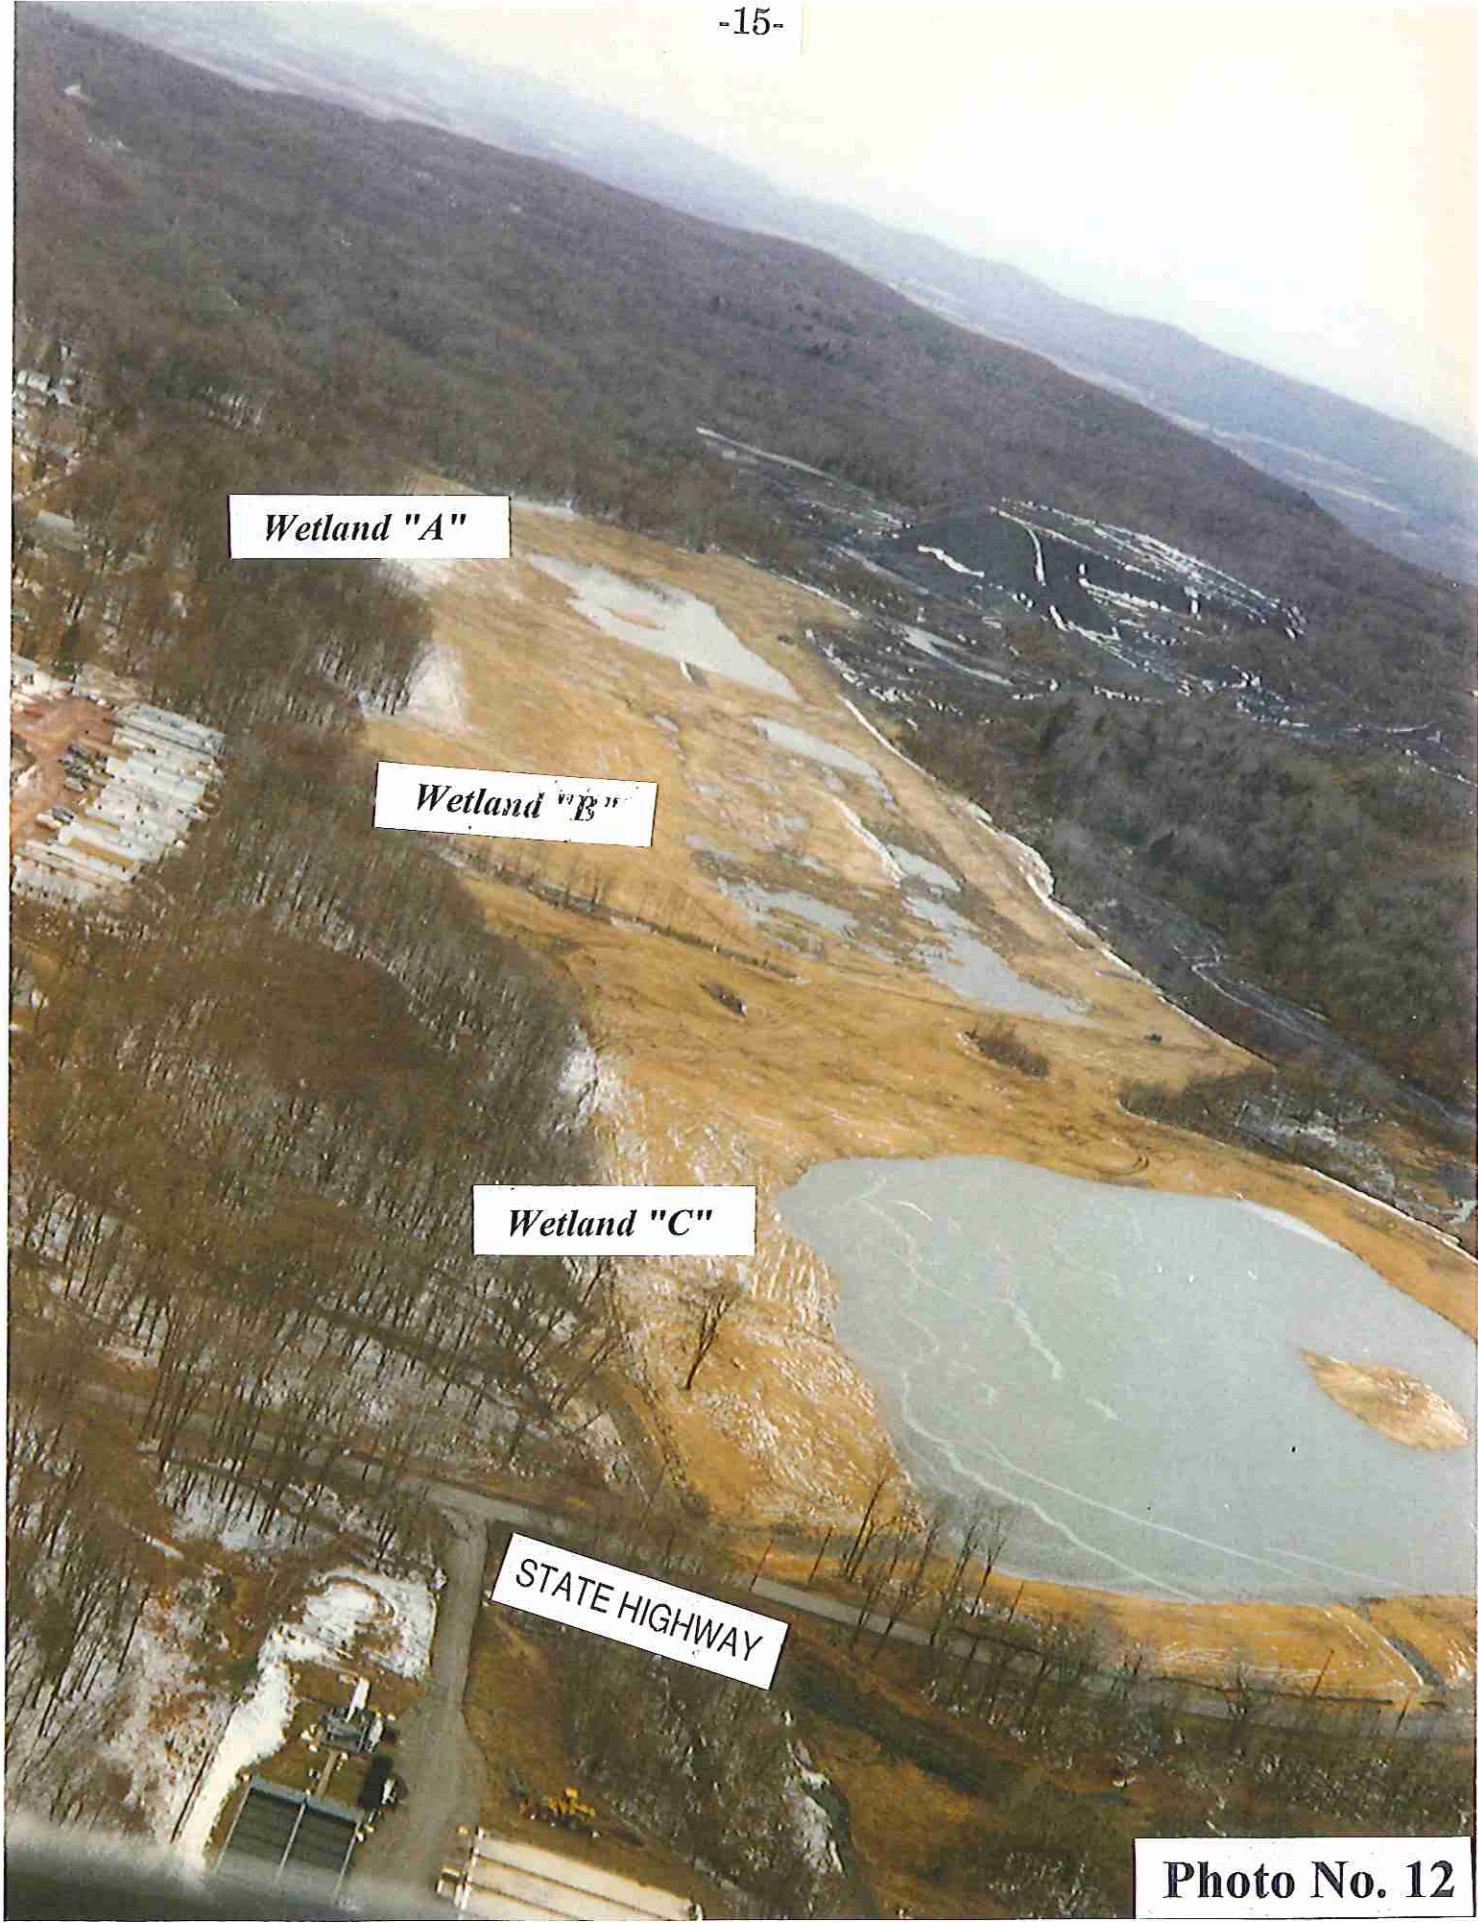
**Photo No. 12**

Photo No. 12 represents an aerial view of the Upper Lehigh reclamation project.
