# UPPER LEHIGH RECLAMATION PROJECT

**NOMINATION  
OF THE  
UPPER LEHIGH  
BACKFILLING STRIP PITS  
OSM 40(3222)101.1  
ABANDONED MINE RECLAMATION PROJECT**

**1997 NATIONAL ABANDONED MINE LAND  
RECLAMATION AWARD  
NOMINATION**

Backfilling Strip Pits  
Upper Lehigh  
Foster Township  
Luzerne County, Pennsylvania  
Contract No. OSM 40(3222)101.1

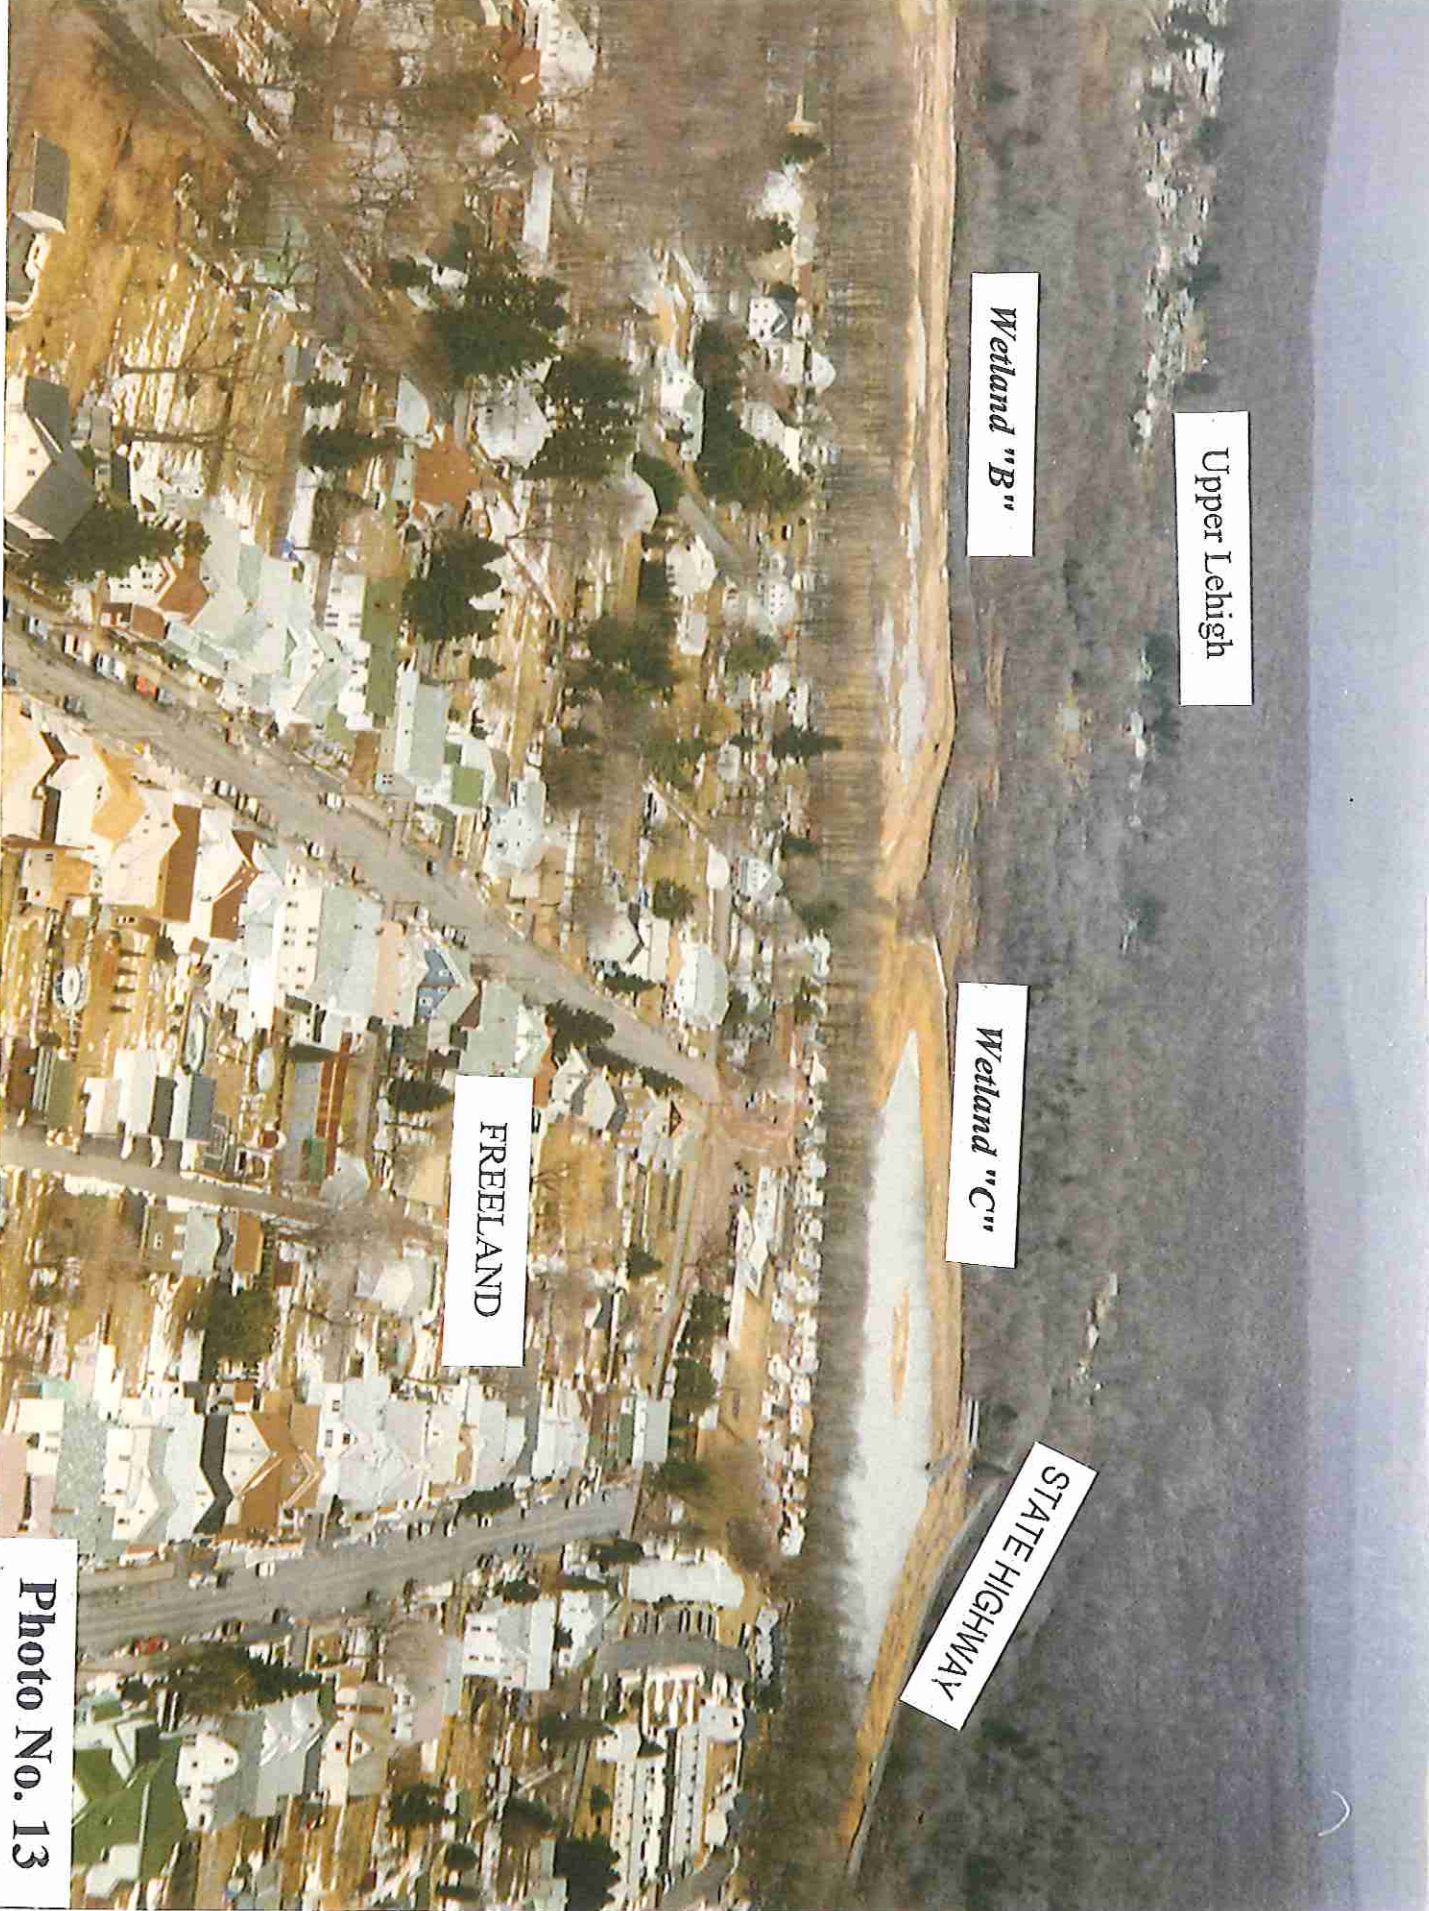
Photo No. 13

This view illustrates how so many people will benefit greatly from the reclamation effort because of the site's proximity to the Borough of Freeland and the Village of Upper Lehigh.

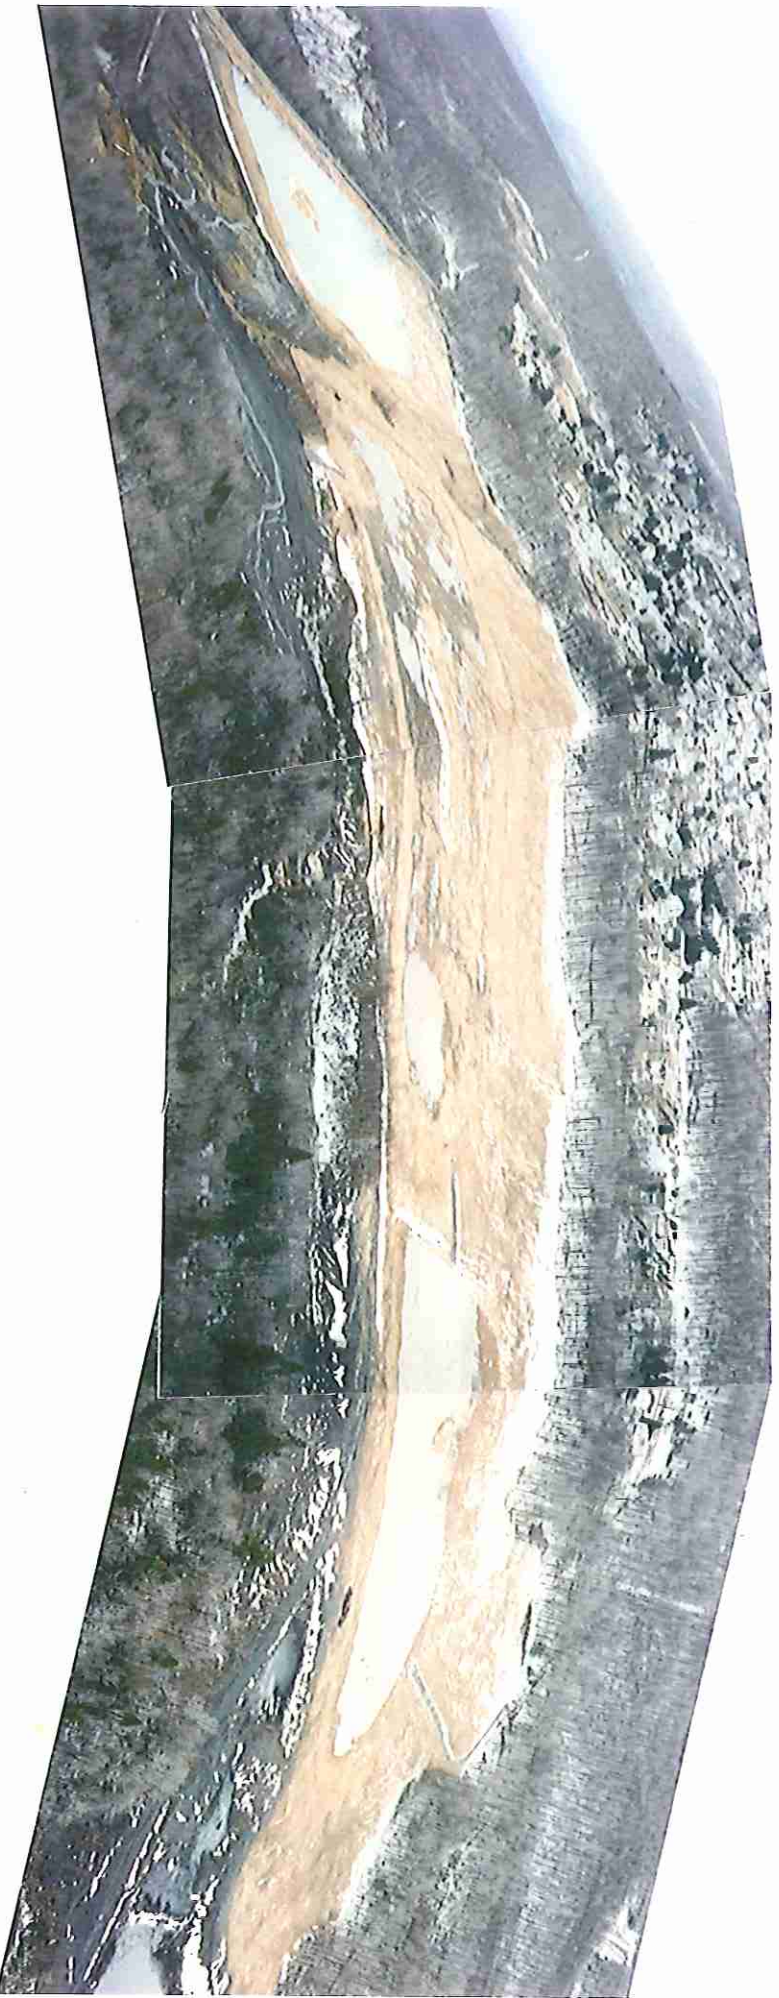
Photo No. 14

This photograph is the one that appears on the cover. It is a mosaic of pictures taken from a helicopter and depicts a panoramic view of the completed reclamation project.

Note: The hydrologic design is already functioning well. Wetlands A & C are holding water and Wetland B is detaining storm water.
